Architectural Program

Dyche Hall – Seventh Floor Partial Renovation & Exterior Restoration

KU Project No. 005-10364

Date: January 2016

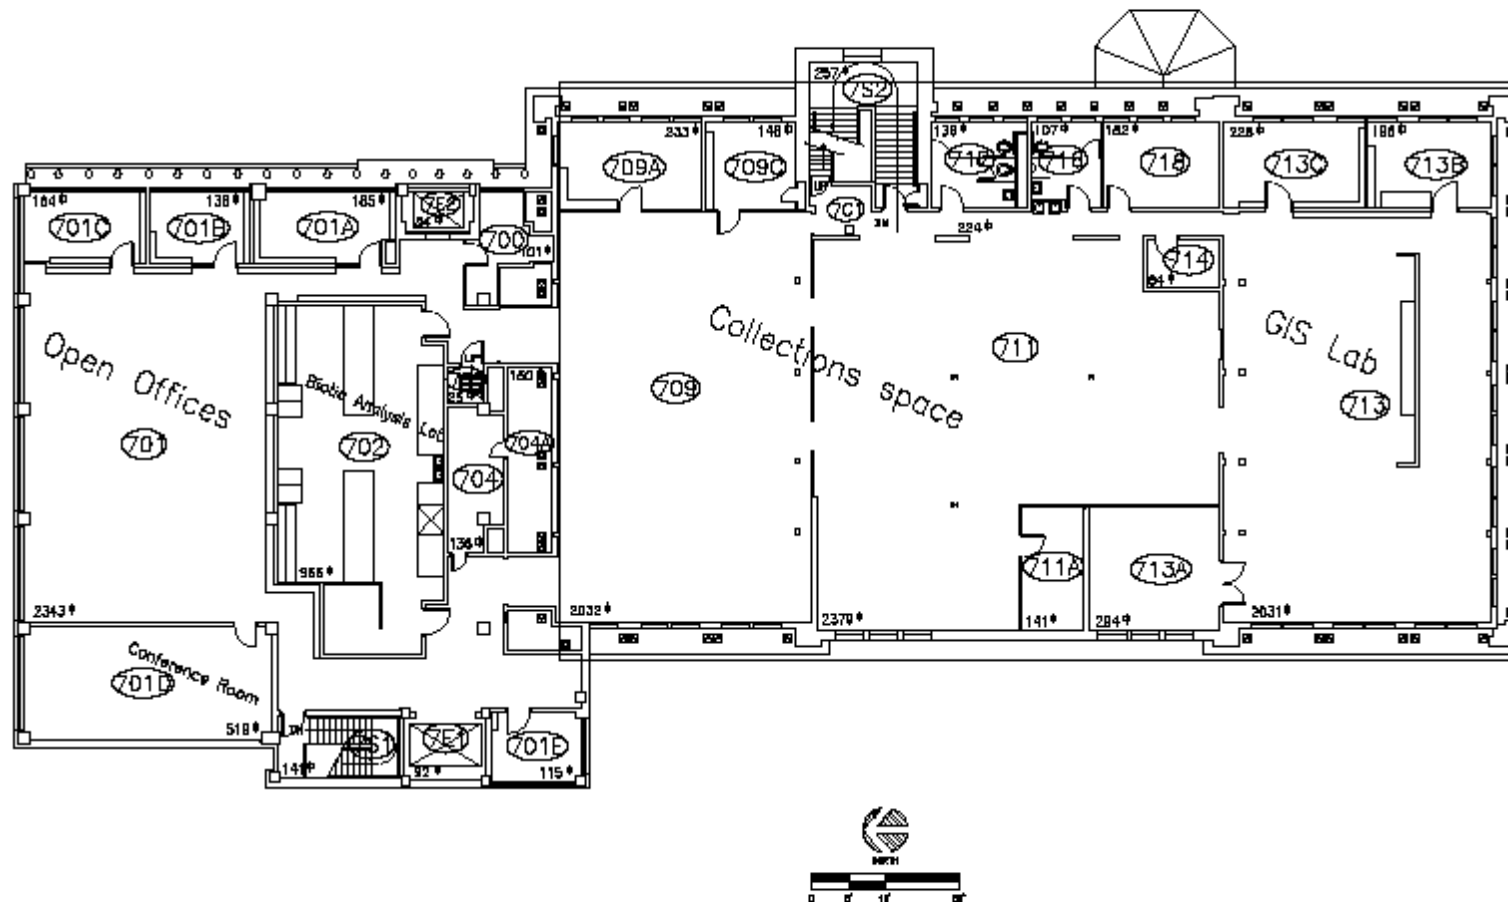
Figure 1 - Current 7th Floor Space Layout

Figure 1: Current 7th Floor Space Layout identifies the footprint of the proposed project work area and illustrates the relative locations of the 6 main function areas.

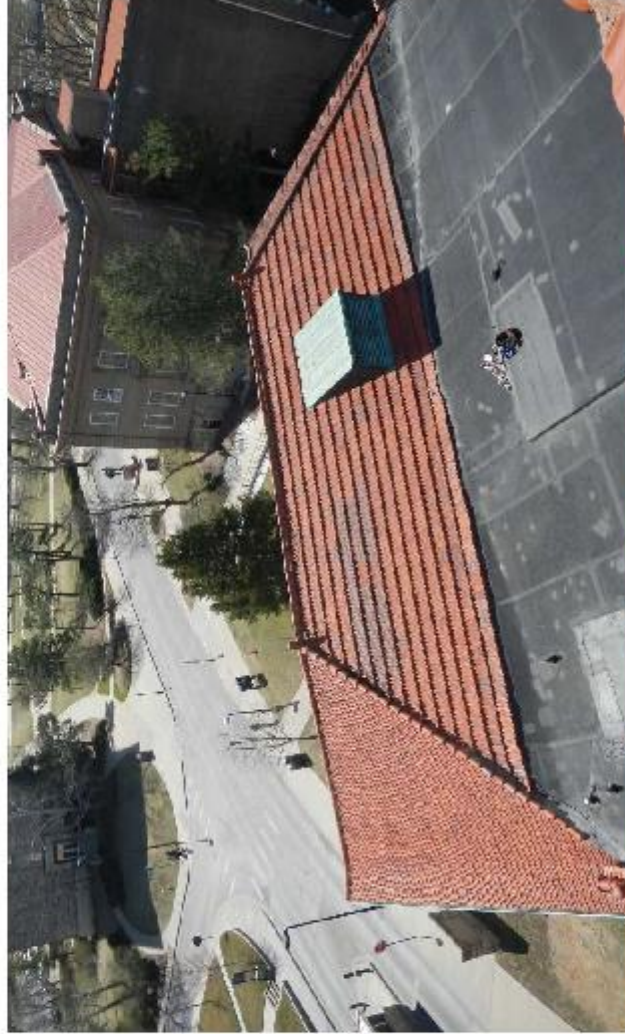
Flat roof and south hip roof viewed from the lower. Existing membrane roof has been patched in multiple locations and is failing to adhere in a large area around the base of the tower. Repairs to the tile roofs have utilized inappropriate materials and techniques at the hips and ridges. Replacement tiles used in previous repairs are mix of sizes resulting in improper filling and lapping in multiple locations. Battens used to secure the tiles are in variable condition, with locations of rot uncovered during the assessment.

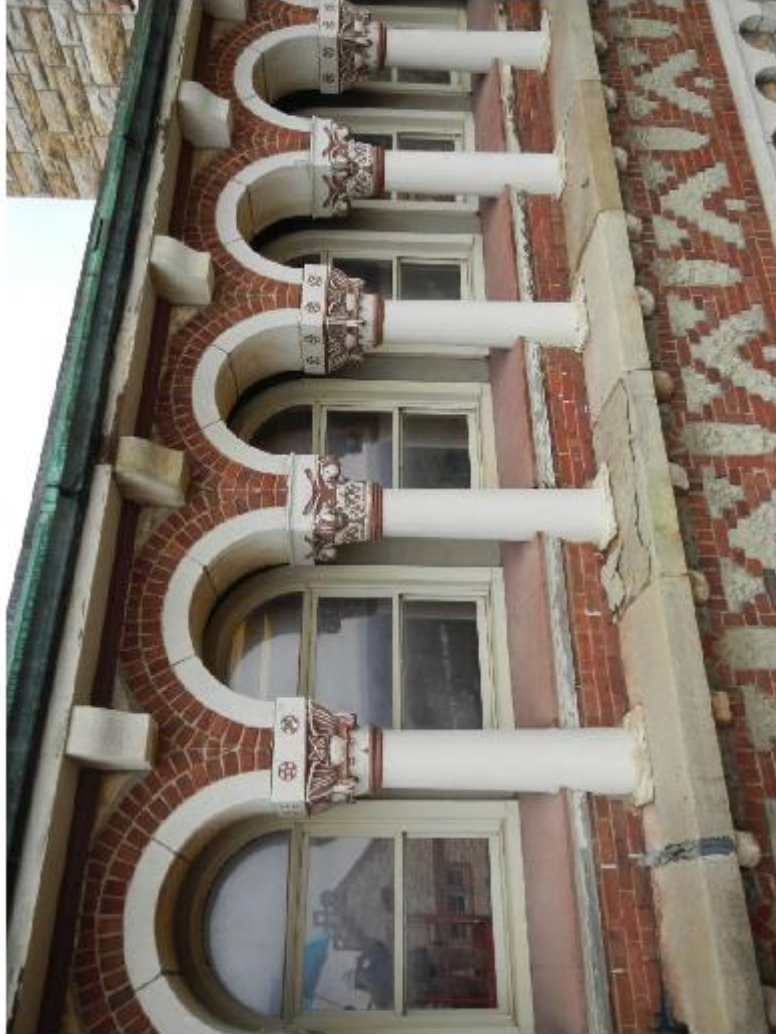
Typical deterioration at the 7th floor east central facade. Note missing mortar joints and on wood trim at window sill. Mortar joints in the brick sill band and stone ledge are deteriorated and open in many locations. Central stone is delaminating due to excessive water infiltration which is a result of the long term underperformance of the gutter above. Bases of cast iron columns exhibit corrosion and paint loss.

The cast iron columns at the 7th floor support a portion of the primary roof framing. And though they appear to be in good condition from the ground, the paint coatings are deteriorating. The deterioration is particularly evident at the capitals and bases. Corrosion of the metal below is evident at all paint losses. Protective coatings on the columns are particularly important in
